# Assessments of Geotechnical Conditions and Slope Stability Analysis: Case Study in Gedo town, Ethiopia

**Abstract** – Slope stability analysis is a vital task to Geotechnical Engineers as slope failures can have devastating social and economic impacts. This paper focuses on the assessments of geotechnical conditions and slope stability analysis of Gedo town, which is located in central Ethiopia, where landslide incidence is active. The study involves a collection of both disturbed and undisturbed soil samples for laboratory tests, such as natural moisture content, unit weight, specific gravity, Atterberg limits, grain size analysis, and shear strength tests were conducted as per ASTM standard. The characteristics of the terrain, soil, groundwater table, and depth and geometry of the failures, were studied in this work. For the slope stability analysis, the safety factor is computed based on the general limit equilibrium method that encompasses various methods inside using slope/w in Geo Studio 2012 software packages. According to the results, the slope in the study area is unstable. The main types of landslide are slides and fall for the soil in the study area, and groundwater,

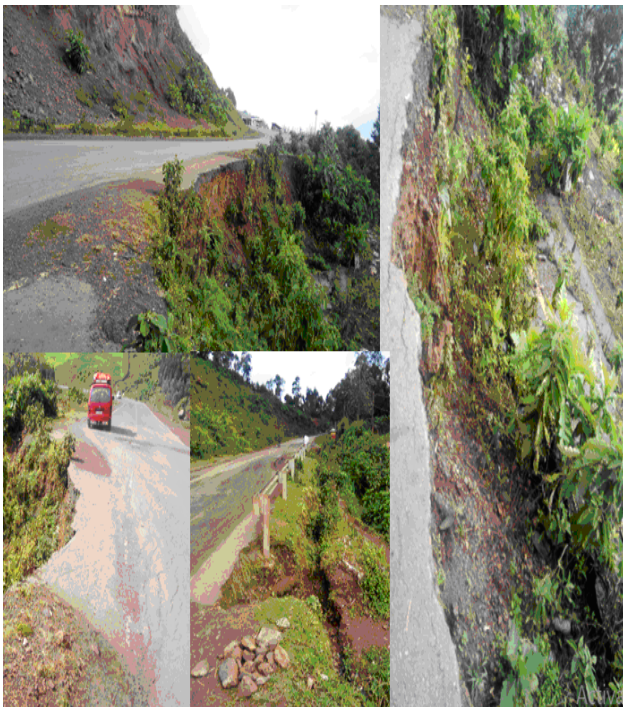
Figure 1: Photograph of the landslide in the Gedo area

According to the previous case studies [5], slope failures in Ethiopia are mainly controlled by the presence of soft and low permeability materials or shales. Landslides are very common in developing countries, and economic losses are sometimes equal or exceed their gross national products [11]. Naturally, Gedo town is located on the mountainous type of terrain and is known to be prone to landslide, as shown in Figure 1.

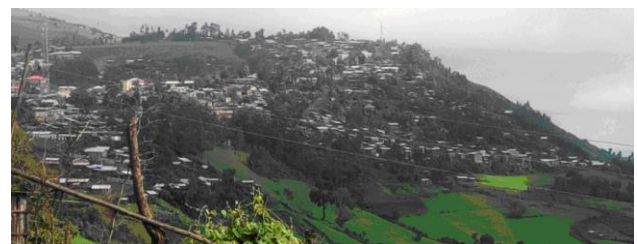
Fig.3. Photograph of the topography of the study area.

The study site is characterized by highly variable topographic features, where the region is dominated by steep hill slope and deep-cut valley. Since the hill slopes are steep enough, external factors such as rainfall and road cut could trigger the angle to failure. Figure 3 shows the topography of the study area.

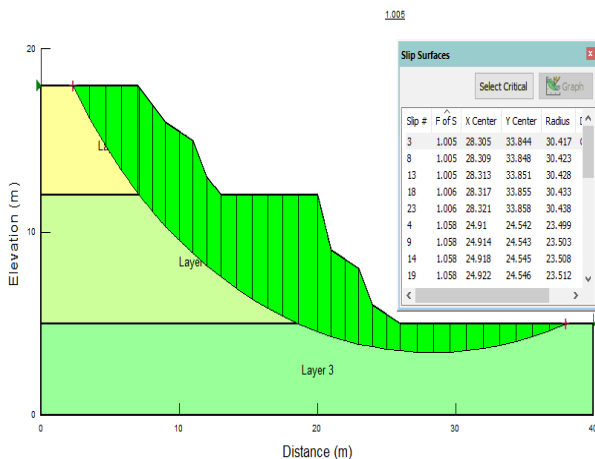
Fig.4. Ideal geometry, critical surface and a minimum factor of safety in Section 1.

When analyzing the stability of a slope, the definition of the critical potential slip surface is an essential step to obtain a minimum safety factor in the selected slope section using a slope/w software. This can be performed by applying various searching options like entering and exiting, grid, and radius, and the search options specified by block [6]. However, in current slope modeling, a critical slipping surface is defined using enter and exit search options. Because it is suitable and can be controlled by the user to adjust the slip surface search until the most critical slip surface is found. Figure 4 shows the critical slip surface of Section 1 using the ordinary analysis method having the geometry of height 18m and width 40m.

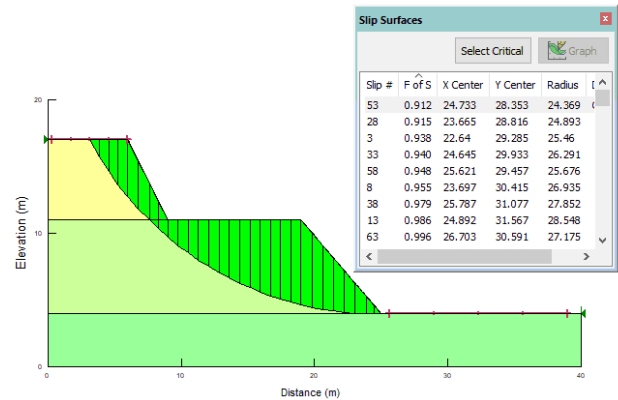
Fig.5. Ideal geometry, critical surface and a minimum factor of safety in Section 2.

Figure 5 shows the critical slip surface of Section 2 using the ordinary analysis method having the geometry of height 17m and width 35m. Figure 6 shows the critical slip surface of section 3 using the ordinary analysis method having the geometry of height 16m and width 35m.

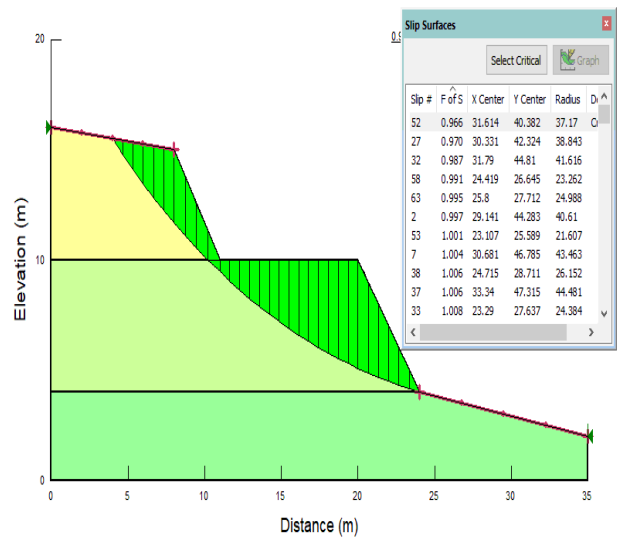
Fig.6. Ideal geometry, critical surface and a minimum factor of safety in section 2.

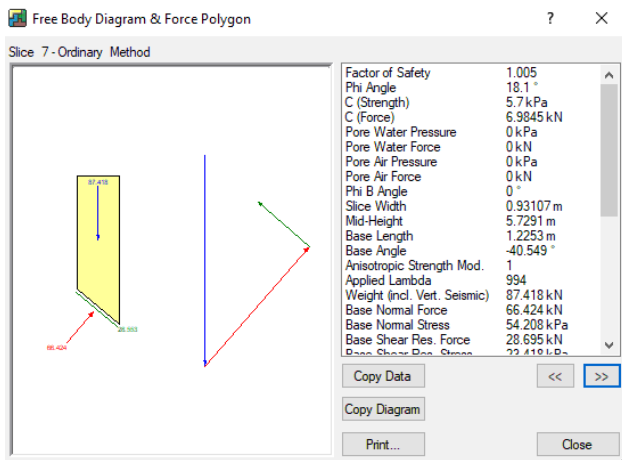
Fig.7. Free body diagram and Force Polygon closure in for Section 1.

This method was applied to calculate the factor of safety for selected failed slope sections under various groundwater conditions but does not take into account the normal, and shear interslice forces and does not satisfy force in equilibrium. Thus, it does not provide a factor of safety vs. lambda graph because lambda is not defined. The ordinary method only satisfies the equation of moment in equilibrium. The force polygon closure is not possible, as shown in Figure 7.

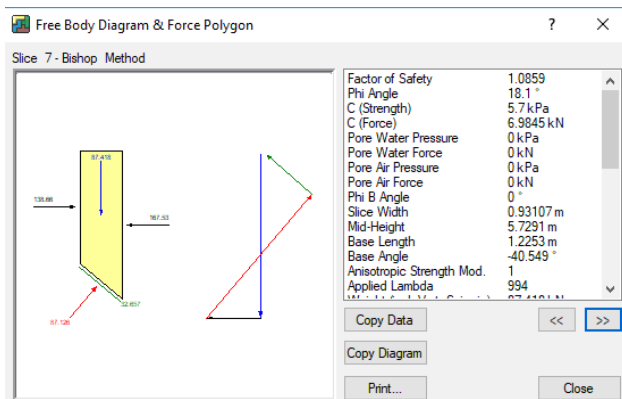
Fig.8. Free body diagram and Force Polygon closure in for Section 1 using Bishop.

This method satisfies the overall moment equilibrium but not the horizontal force equilibrium. It has inter-slice normal force but not inter-slice shear force. The force polygon closure was examined under similar slice numbers, which is an excellent contrast to the ordinary one, as shown in Figure 8 below. The sliding masses are almost in horizontal force equilibrium. In the case of a factor of safety vs. lambda graph, unlike the ordinary-simplified method, Bishop's simplified method factor of safety falls in the moment equilibrium curve when lambda is zero, as shown in Figure 12.

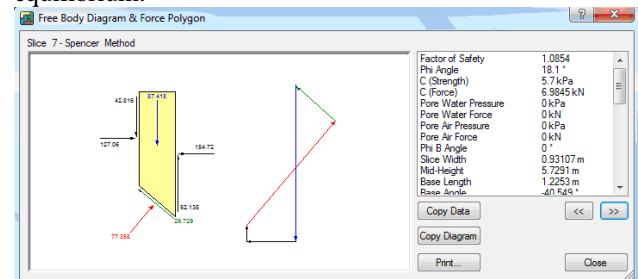
Fig.10. Free body diagram and Force Polygon closure in for Section 1 using SM.

This method satisfies both the moment and the force in balance. At the same time, this method takes inter-slice forces into account and assumed the constant relationship between the inter-slice shear force and normal force. It has quite good force polygon closure, as shown in Figure 10. Consequently, all slices are in force equilibrium. Unlike Bishop and Janbu, the value of lambda is greater than zero, as shown in Figure 12. This method has both inter-slice shear and normal force because lambda is the ratio of interslice shear to the inter-slice normal force. This method is used to calculate two factors of safety, like the factor of safety concerning moment and force equilibrium.

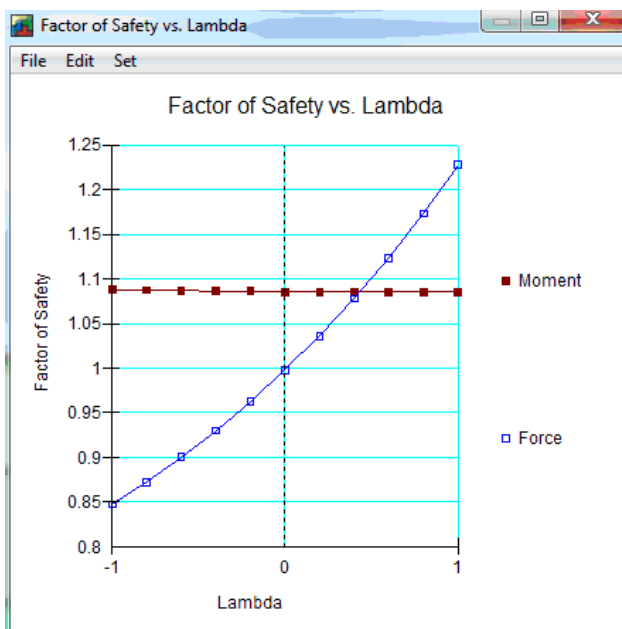
Fig.12 . Factor of safety Vs Lambda graph.

various inter-slice force functions. Therefore, this method is the best of all the other limit equilibrium methods. This method satisfies all equations of statics and used to plot the factor of safety vs. lambda graph that is so important to compare the factor of safety in each method.

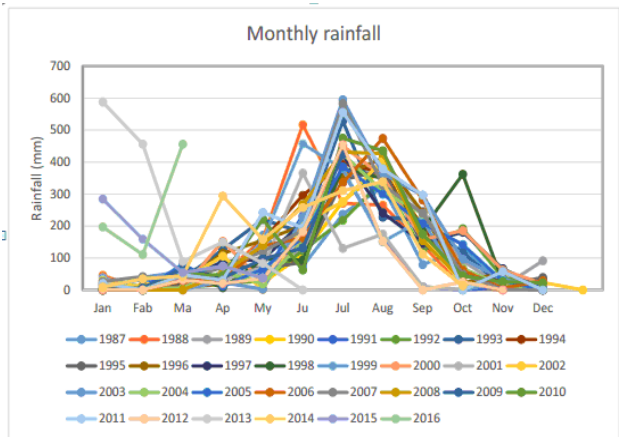
Fig. 13. Monthly based rainfall of Gedo town from 1987-2016.

Slope failure has occurred in the middle, end of July, August, and September with intense and prolonged rainfall in the study area. As indicated in the bar graph of Figure13, the rainfall intensity varies from month to month. For instance, the rainfall intensity in July, August, and September are so high. The information that has gathered from local people interview, natural soil moisture test result, liquidity index, and Google Earth image interpretation indicates landslides in the study area have occurred related to heavy and prolonged rainfall. Thus, rainfall is one of the most important triggering factors for slope failure in the study area. As designated in Table 1, the natural soil moisture content of the soil increases with depth for the selected failed slope section. It implies the fluctuation of soil moisture due to the effects of rainfall. This result shows, during the rainy season, the humidity of soil increases and causes the unsaturated reduction zone of the soil profile. It also causes a reduction of shear strength but the increasing weight on the slope and driving force. These all trigger the slope instability in the area. However, the presence of heavy and prolonged rainfall in a given region may not cause landslide unless other conditioning factors are available. In the study area, in particular, cool zones that
