Study Report on Failure Analysis of TMT Bar Due to Steel Defects

Abstract- Thermo-mechanical treated (TMT) rebar is used as material for reinforcing concrete structures due to its unique Properties of thermal expansion, ability to bond well with concrete and resist the tensile stress acting on the structure and also steel manufacturing industry has successfully developed a corrosion- resistant variety of rebar for the construction industry. By controlling the proper rolling parameters and water quenching box is required to achieve adequate property. Water quenching box & used billets plays an important role for achieving the final structure and property of the rebars as well the bend properties. Steel quality of the rolled billets are for the production of good surface finish quality TMT bar & also passed in bending of bar. The present paper highlights failure investigation of a failed rebar during bending operations. From micro structural analysis & study of fracture surface it is confirmed that the rebar sample failed in ductile manner due to the steel defects like sub surface blow holes inside the rolled billets originating from thecaster.

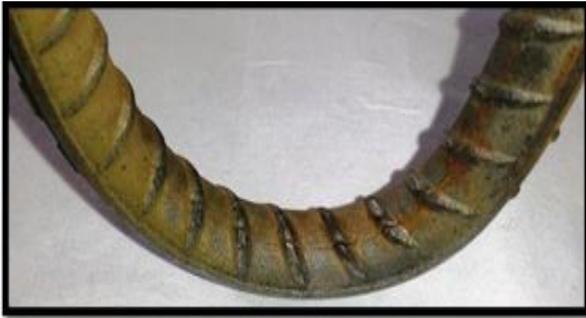
Fig 1. 8mm TMT Bar cracked during bending of operation on the transverse rib.

Cast number of failed re bar samples trace out to see the macro etched billets internal defects of the tolled TMT bar & macro etched samples of failed bar thoroughly studied visually as shown in figure- 2. Also, the end cut samples of shear cut collected from mill stand of same heat billets for visual study & it was shown in figure -3. The TMT failed bend samples was shown in figure -1.

1. Visual observation: Visual observation of the cracked samples done and it was found that the crack is elongated during the rolling process. In the billet inspection it was also seen that blow holes and piping defects observed as shown in the figure 1 and figure 2 a and b. These defects are generated during the casting process and rolling of the billets. The TMT bar showing the line types of cracked defects along with the rib of the samples.

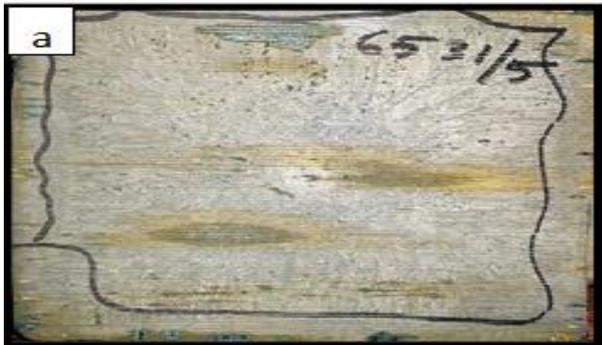
Fig 2. (a) Image of billet samples showing blow holes (b) Image of billet samples showing blow piping defect in the center of the sample.
