Slope Stability Analysis of Landslide at Fudale, Gamo Zone, Ethiopia

Amanuel Abera, Bisrat Gissila, Democracy Dila, Vasudeva Rao
Faculty of Civil Engineering, Arba Minch University Arba Minch, Ethiopia

Index Terms- Landslides, Factor of Safety, FEM, Plaxis 2D, Slope Stability

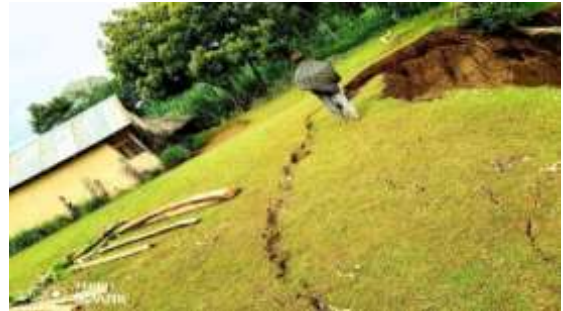
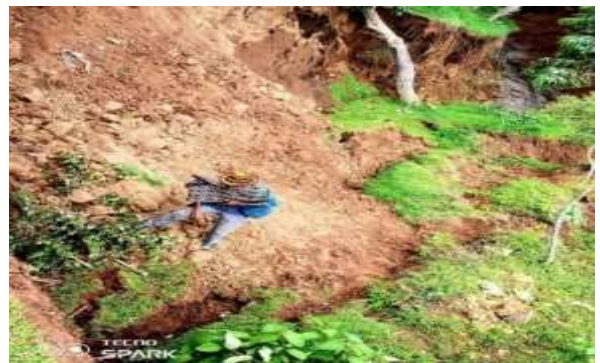
A landslide in Fudale caused environmental destruction, causing trees to fall, soil to fracture, and land mass to collapse. The stream, once flowing, diverted and spread across the distorted area, with some remaining at the side. The surface damage due to the landslide in the research area is shown in figure 1.

Figure 1: Surface damage due to landslide of Fudale landslide

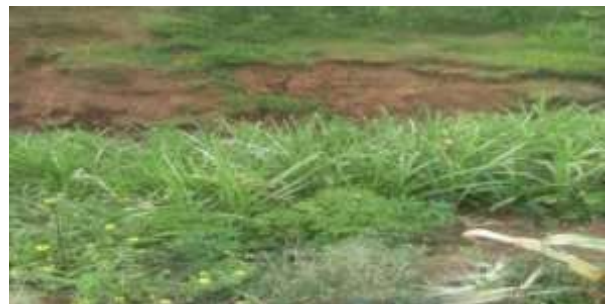
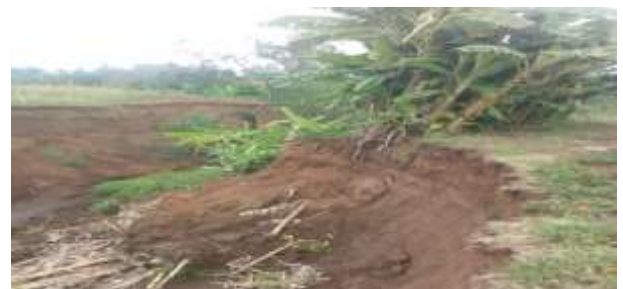
Land subsidence caused the destruction of banana plants and fruits in a study area, causing a landslide and pond overflow, causing damage to homes and disruption to people's livelihoods. The destruction of plants and fruits due to the landslide in the research area is shown in figure 2.

Figure 2: Destruction of plants and fruits due to landslide of Fudale Landslide

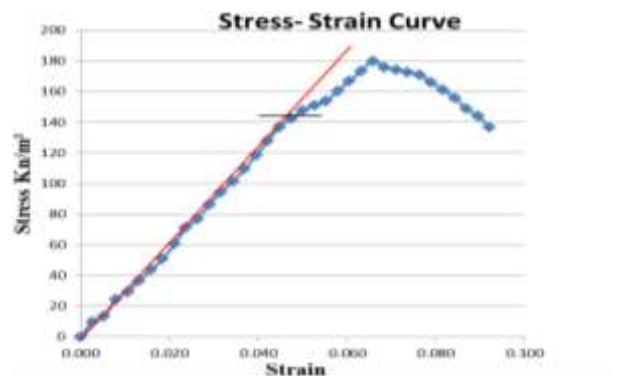
The elastic modulus, calculated from a stress-strain curve derived from a triaxial test, was used to evaluate slope stability in soil samples, ranging from 3,394 to 5,375 kN/m². The stress-strain curves as shown in figure 1 (i & iii) and the elastic modulus can be derived from the stress-strain curves as shown in figure 1 (ii & iv).

Figure 3: The determination of the elastic modulus can be derived from the stress-strain curve.

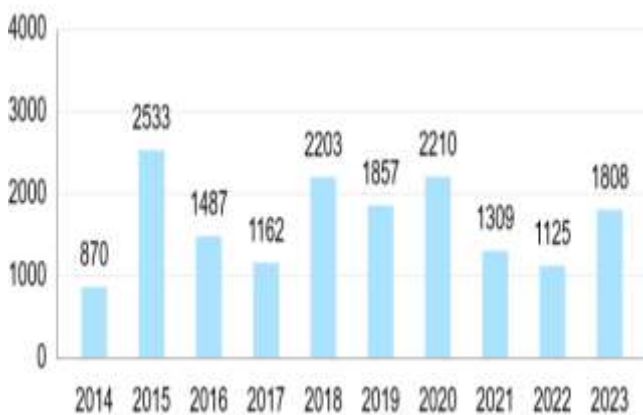
Rainfall in Fudale has increased since 2014, with the highest recorded in 2015. This led to increased ground surface fissures and decreased soil shear strength, resulting in landslides. The average annual rainfall is 1659 mm, with extremes of 2533 mm and 870 mm. A summary of the annual rainfall in Fudale is illustrated in Figure 4 below.

Figure 4: Annual rainfalls Analysis

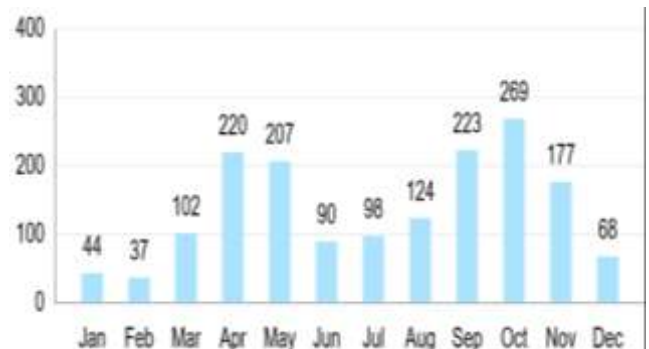
The monthly rainfall assessment in Fudale shows year-round precipitation, with low levels in January, February, and December, and the primary rainy seasons being April, May, August, September, October, and November. A summary of the monthly rainfall in Fudale is illustrated in Figure 5 below.

Figure 5: Monthly Rainfall Analysis

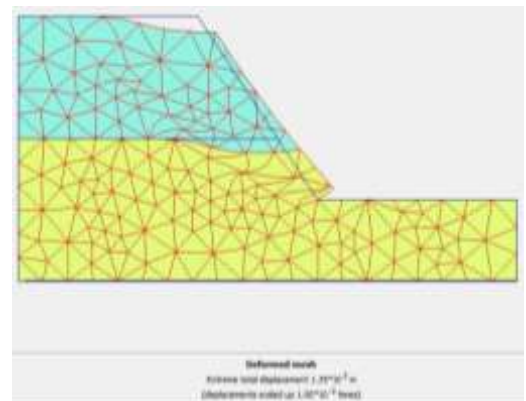
The deformation analysis was conducted using plastic calculation, focusing on an elastic-plastic deformation assessment with constant stiffness, and slope sections were evaluated under static loading conditions. The Deformation of the slope of the research area is shown in figure 12.

Figure 12: Deformation of slope

The analysis reveals peak deformation at the uppermost soil layer, specifically at the scarp, confirming field surveys and laboratory tests. The clayey silt layer is potentially unstable, with shallow failures and significant impact on slope stability during rainfall periods, despite not considering groundwater levels and GWT.

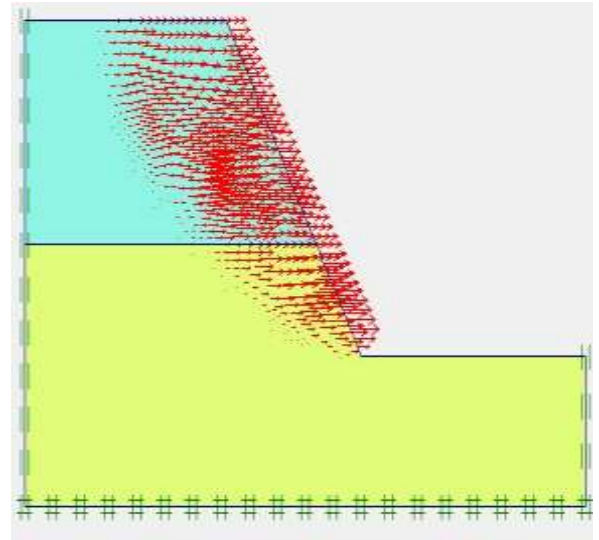
Figure 17: Direction of soil movement
